**DEPARTMENT OF TRANSPORTATION****DIVISION OF ENGINEERING SERVICES**

Quality Assurance and Source Inspection

Contract #: 04-0120F4Cty: SF/ALA Rte: 80 PM: 13.2/13.9File #: 1.28**WELDING INSPECTION REPORT****Resident Engineer:**Siegenthaler, Peter**Address:** 333 Burma Road**City:** Oakland, CA 94607**Report No:** WIR-019449**Date Inspected:** 10-Jan-2011**Project Name:** SAS Superstructure**OSM Arrival Time:** 630**Prime Contractor:** American Bridge/Fluor Enterprises, a JV**OSM Departure Time:** 1500**Contractor:** American Bridge/Fluor Enterprises, a JV**Location:** Job Site**CWI Name:** See Below**CWI Present:** Yes No**Inspected CWI report:** Yes No N/A**Rod Oven in Use:** Yes No N/A**Electrode to specification:** Yes No N/A**Weld Procedures Followed:** Yes No N/A**Qualified Welders:** Yes No N/A**Verified Joint Fit-up:** Yes No N/A**Approved Drawings:** Yes No N/A**Approved WPS:** Yes No N/A**Delayed / Cancelled:** Yes No N/A**Bridge No:** 34-0006**Component:** Orthotropic Box Girders**Summary of Items Observed:**

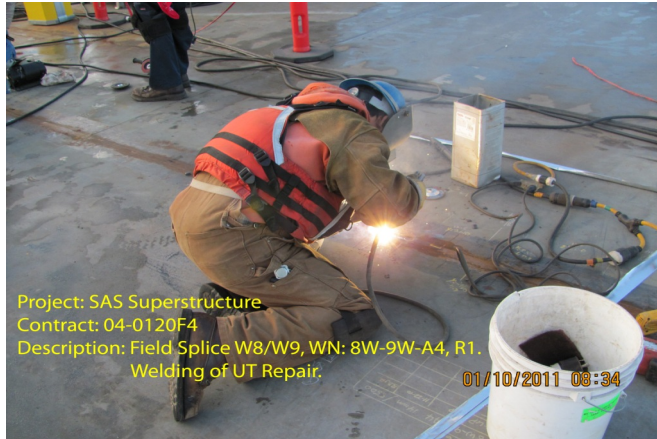
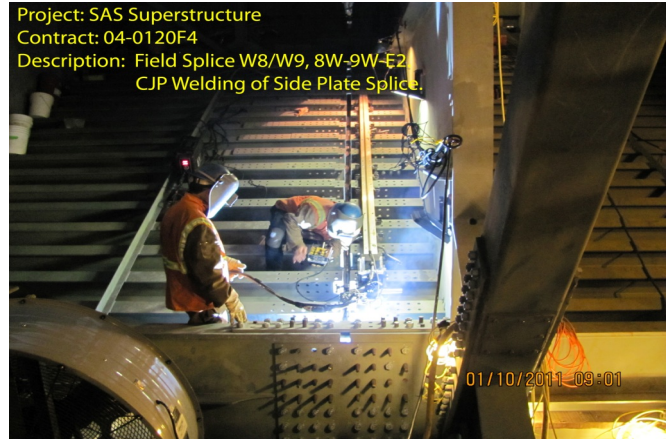
The digital photographs on page 4 of this report illustrate some of the work observed during this scheduled shift.
